Manhole Inspection Summary

Manhole # S25C__017MH

Location Address: **1212 FRANKLIN ST**

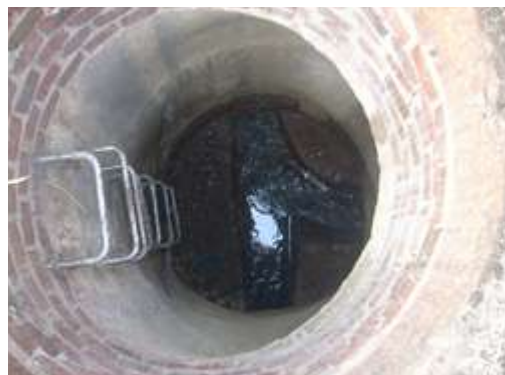
Top View

Comments **HUGE CRACK ON CORBEL**

Condition: ☐ Sound ☒ **Cracked** ☐ Root Intrusion ☐ Loose Brick ☐ Deteriorated
